Marginal Summary

Property Address 1234 School House Road
City Yourtown State US Zip 12345
Contact Name Ima Goodagent
Phone (111)-111-1111 Fax (111)-111-1111

Inspector Name Jim Johnson
Company Name Inspection Plus
Company Address 5381 Autumnwood Drive
City Cincinnati State OH Zip 45242
Phone (111)111-2111 Fax (111)111-2111
E-Mail inspections@inspector.com
File Number 22222
Amount Received \$350.00

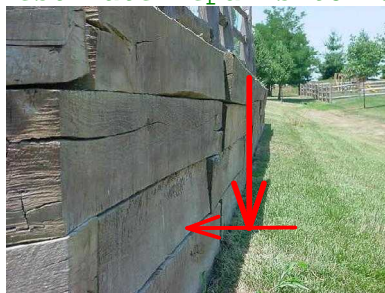
1. Vegetation: Shrubs with some weeds
2. Retaining Walls: Railroad ties The wall is showing signs of movement, but appears to be stable at this time. A qualified contractor is recommended to evaluate and estimate repairs to maintain the wall.

| 8. | <input type="checkbox"/> | <input type="checkbox"/> | <input type="checkbox"/> | <input checked="" type="checkbox"/> | <input type="checkbox"/> | <input type="checkbox"/> | Retaining Walls: Railroad ties The wall is showing signs of movement, but appears to be stable at this time. A qualified contractor is recommended to evaluate and estimate repairs to maintain the wall. |

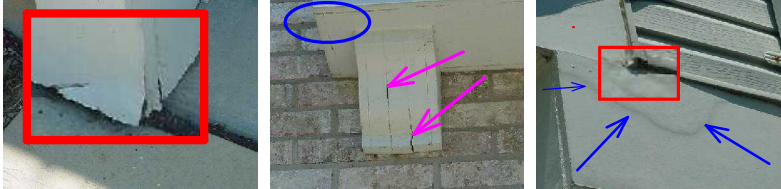
1. Water damage to trim wood at either side of garage door from moisture wicking into the finished particle board. The surface is starting to delaminate. Recommend repair/replacement of the trim boards and silicone seal wood that is in contact with concrete to prevent wicking.

2. The wood window boxes have water damage and will require repair/replacement. The wood has started to separate at the supports and at the corners of the window boxes.

3. The trim board at the southwest corner of the porch has water damage due to water penetration and will require repair/replacement of the wood. The trim board extends out creating a ledge allowing water to collect on the top edge of the board and cause the wood to rot.

Recommend estimate/repairs by a qualified contractor.

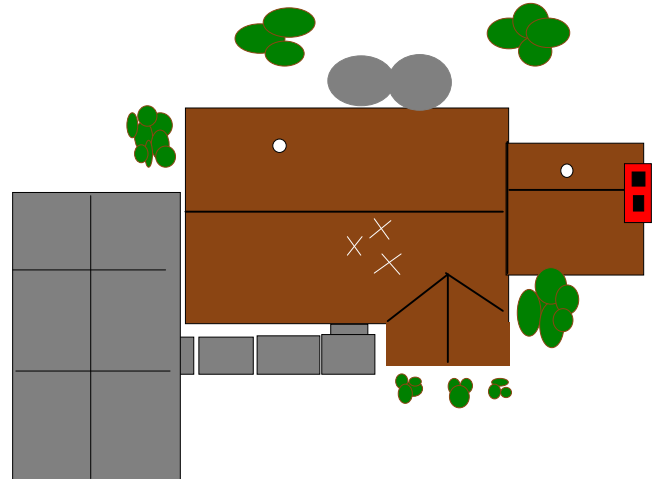
1. Method of Inspection: On the roof
2. Unable to Inspect: 30% Height of the roof
3. Material: Fiberglass shingle Missing roof shingles from wind damage as marked "x" in diagram. Repairs are required.
4. Type: Gable
